CONCERTO project in Galanta

Geothermal Communities

Structure of the demonstration site

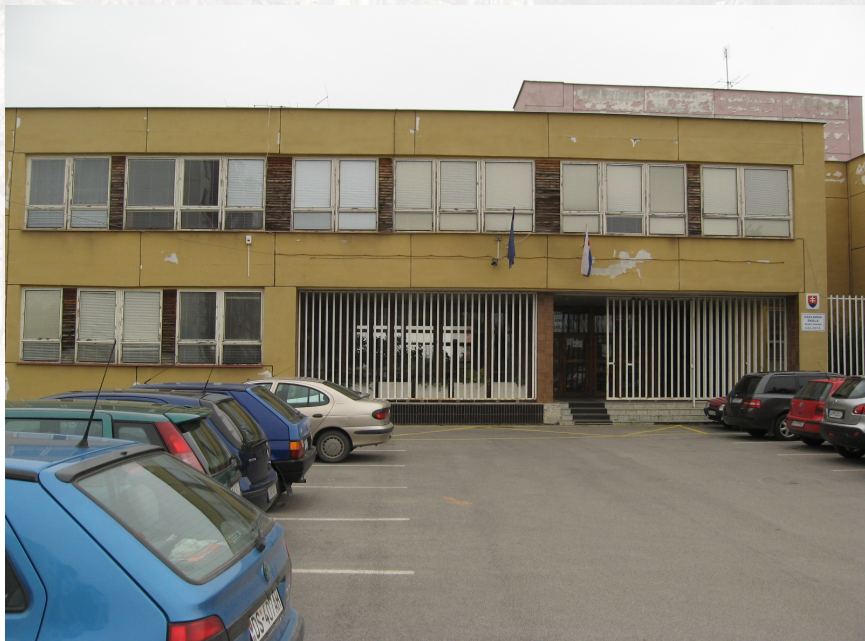
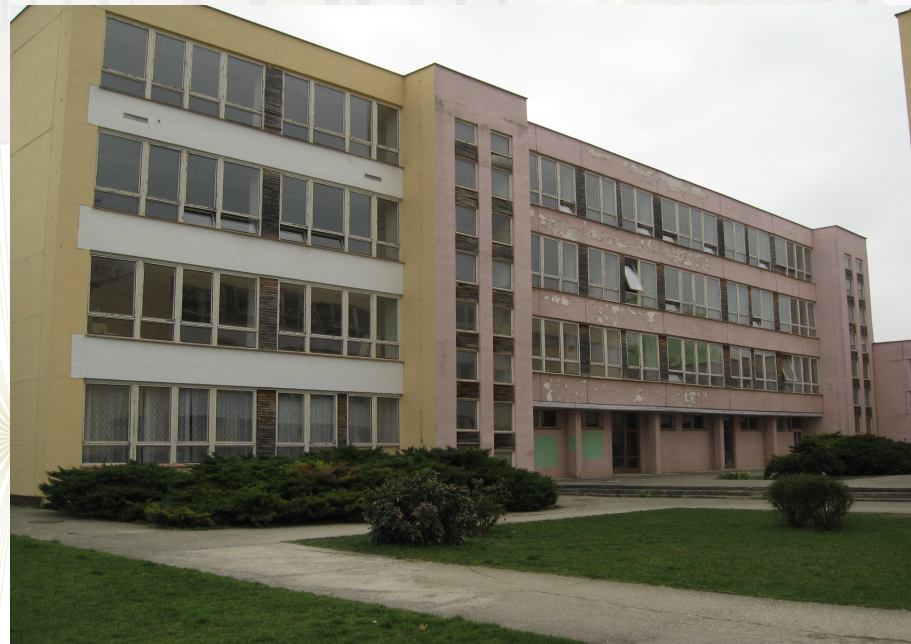
Before realization

- This activity is aimed on elementary school Gejzu Dusika which is heated from the geothermal source
- Due to higher than expected budget, this activity was divided into two phases (each phase a year)
- Technical specifications:
 - 6 cell plastic insulated frames with $U_f = 1,1 \text{ Wm}^{-2}\text{K}^{-1}$
 - Insulated double glazing 4 – 16 - 4 mm with $U_g = 1,1 \text{ Wm}^{-2}\text{K}^{-1}$
 - Overall U-value of the windows and doors: $U_w = 1,3 \text{ Wm}^{-2}\text{K}^{-1}$
 - According to pre-implementation studies, this activity could achieve a saving up to 30%

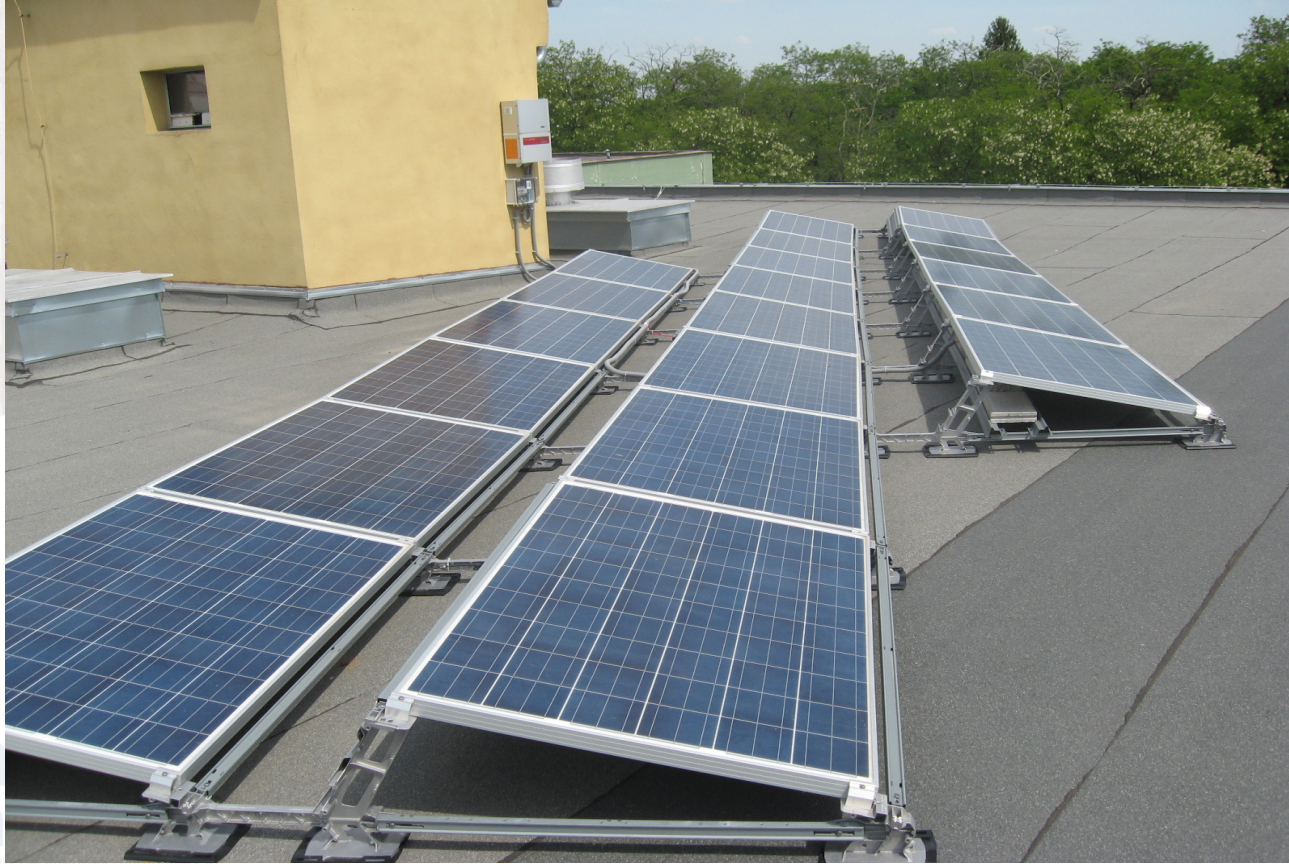
Photovoltaics on elementary school Gejzu Dusíka

- **Small scale photovoltaics** - The annual energy performance of the system by is 4,86 kWp, which means annual energy gain of 4761 kWh. The PV is mounted on the roof of elementary school Gejzu Dusíka.
- **Lighting system renewal** - a comprehensive audit was realized. The result of the audit that can be achieved: energy savings of 23,7 %, what means 51 429 kWh savings per year. With the recent price rates it means 6 172 € of savings per year on the electricity costs. THIS ACTIVITY IS NOT FINISHED YET

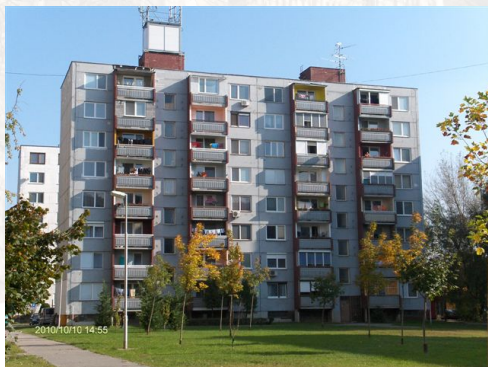
Mierová 1436

Situation Before the Retrofitting

External walls on the facing - 300 mm aerated concrete boards; **shield** - 150 mm reinforced concrete boards.

Roof - 250 mm aerated concrete panels, 2 x 40 mm basalt wool and 150 mm concrete panel boards on the ceiling.

Loggias - prefabricated reinforced panel boards. Set-out is approx. 1,2 m.

Doors and windows at the common spaces - not insulated, made by a single glass and steel frame.

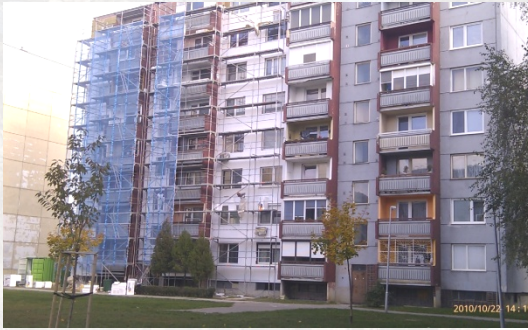
Mierová 1436

Retrofitting Features

Doors and windows at the common spaces - replacement for double glass with vacuum insulation, U-value: 1,1 W/m² x K, 5 cell plastic and aluminium frame

Facade insulation - 70 mm EPS polystyrene till 22,5 m height; 70 mm rockwool above 22,5 m height

Roof insulation - 100 mm XPS polystyrene, roof foil and geotextile separation layer

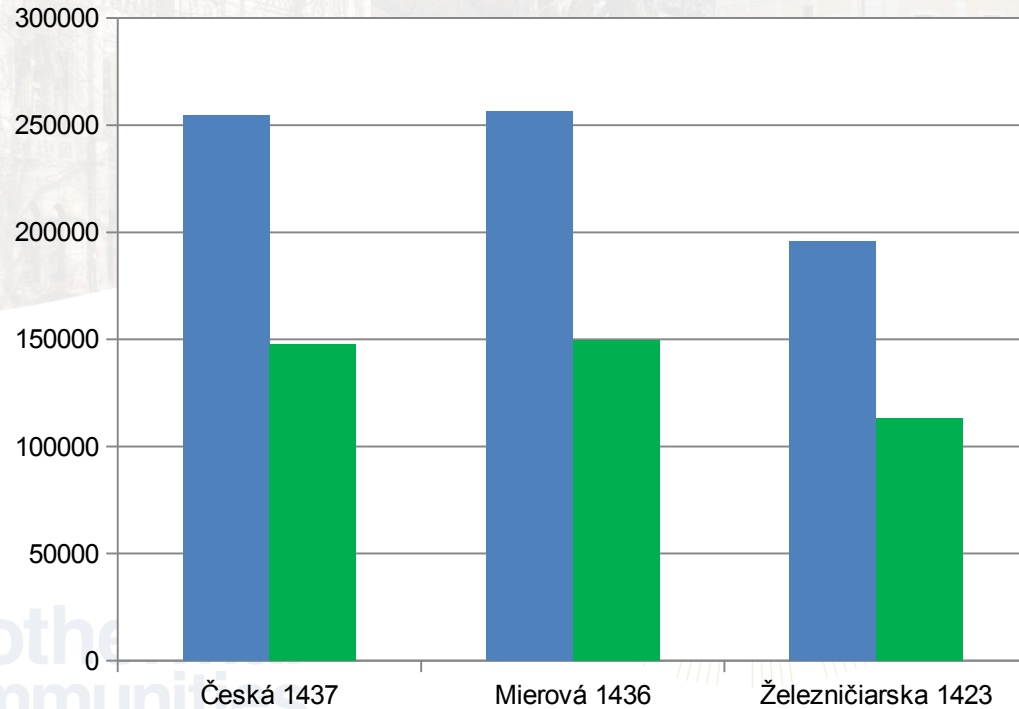
Energy Performance Evaluation Comparison of Heat Requirement

■ Heat requirement before retrofitting
■ Heat requirement after retrofitting

Multi-storey house	Heat requirement of the building (kWh/y)	Heat loss of the building (W/K)	Standardized heat requirement on m ² (kWh/m ² x y)
Česká 1437	254 452,00	4331,67	77,98
Mierová 1436	256 601,00	4377,03	77,98
Železničiarska 1423	196 132,00	3521,82	75,71

Multi-storey house	Heat requirement of the building (kWh/y)	Heat loss of the building (W/K)	Standardized heat requirement on m2 (kWh/m2 x y)	Heat requirement savings due to retrofitting (kWh/y)	Heat requirement savings due to retrofitting (%)
Česká 1437	147 683,00	3 031,51	49,22	106 769,00	41,96
Mierová 1436	149 831,00	3 076,87	49,94	106 770,00	41,60
Železničiarska 1423	113 278,00	2 512,89	41,85	82 854,00	42,24
